STUDY INTO THE EFFECTIVENESS OF CORAL ENTRANCE MATTING

Introduction

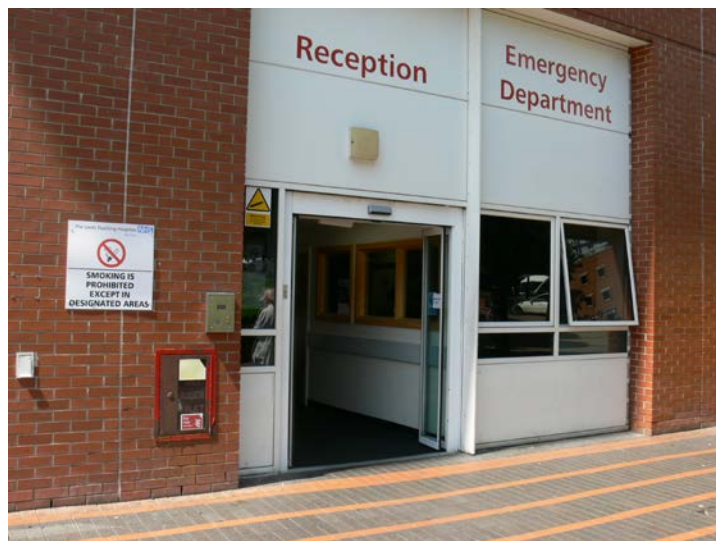
Figure 2. Accident and Emergency Entrance

The entrance to Accident and Emergency was chosen for the installation, this being selected by the hospital as being a very busy site with some 800 – 1000 footsteps every 24 hours representing some 7000 footsteps per week.

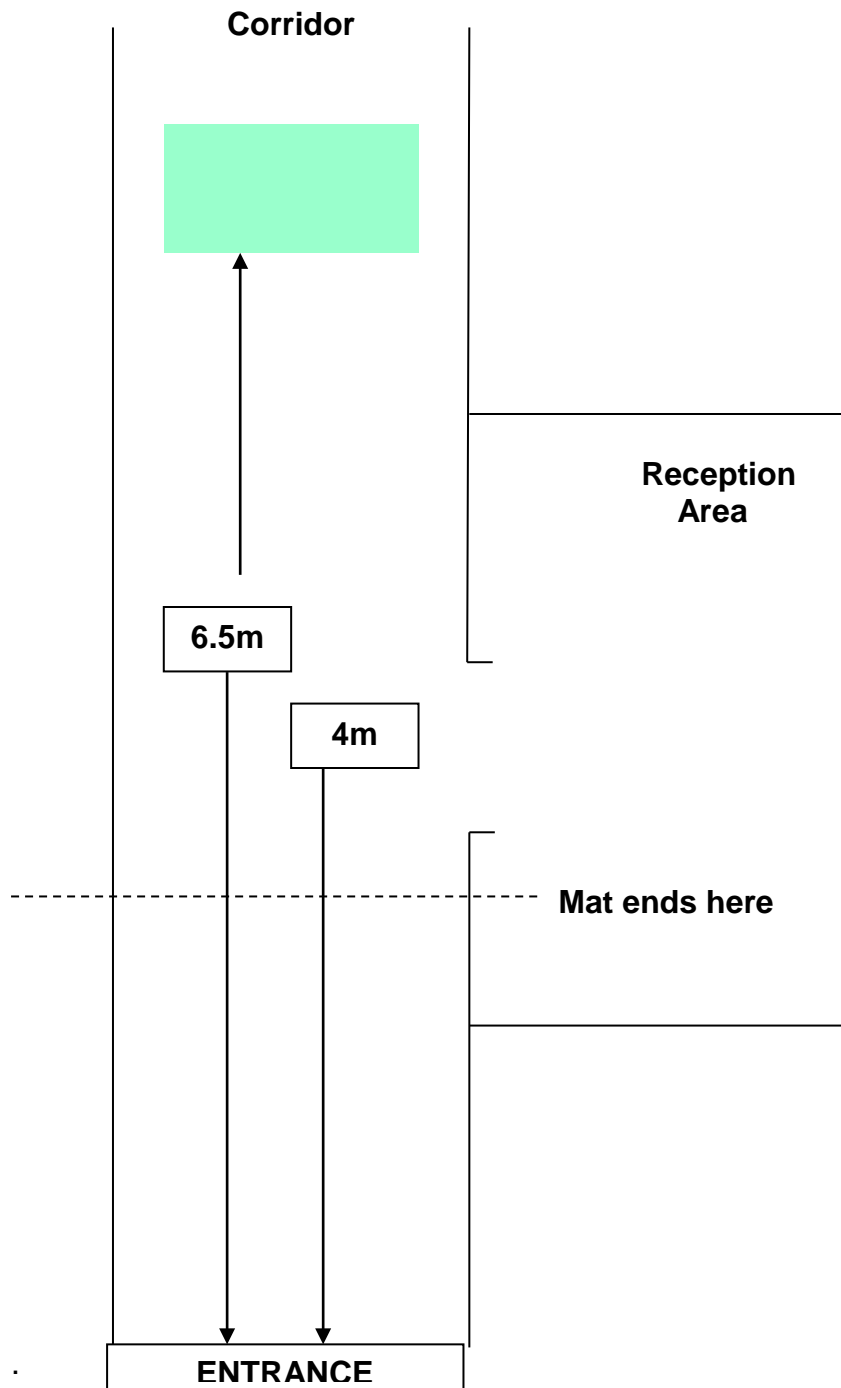
Figure 3. Site Layout

Figure 3 shows the layout of the site

The area was approached through double doors leading to a long, straight corridor with a reception area off to the right hand side some 4 metres from the door

The first series of trials were carried out without any protective mat in place. Tests were carried out at a distance of 6.5 metres from the door – coloured green in the site diagram

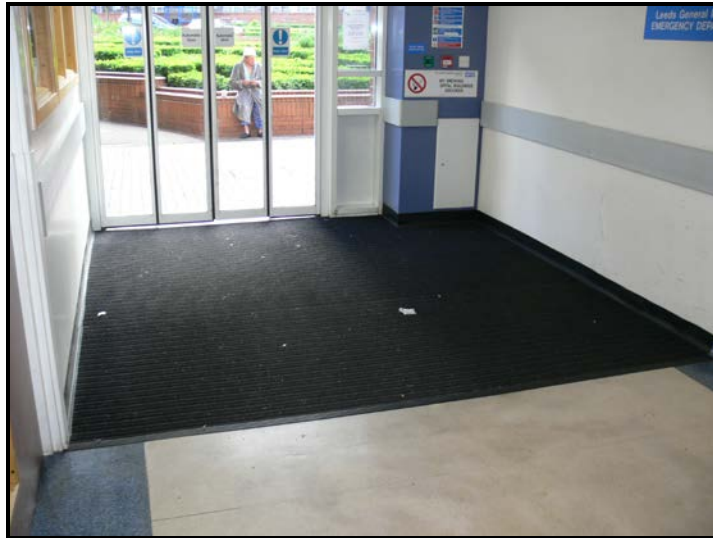
Figure 4. Installation

Three metres of Coral entrance matting was then installed and measurements of soil levels were then determined on four successive weekly visits. The level of soil now present on the floor was very significantly reduced as can be seen in Table 1.

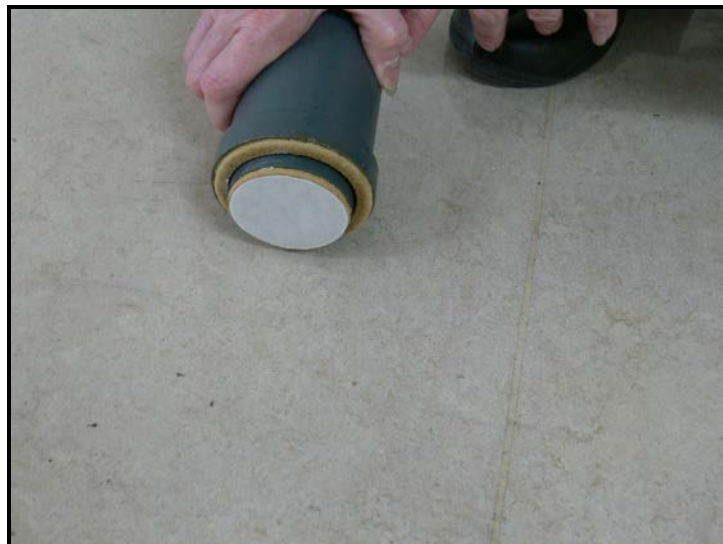
Figure 5. Camraso Soil Monitor Device

Levels of soil present on the floor were obtained using the Camraso Soil Monitor. This is an instrument which transfers soil from the floor onto a pre-weighed GF/C filter paper. The paper is subsequently dried to constant weight, and the increase in weight represents the weight of soil picked up from the floor. Six replicate samples were obtained from the area under test
